**ANALYZING SIDEWALK ACCESSIBILITY FOR PEOPLE WITH DISABILITIES:
A CASE STUDY OF LVIV, UKRAINE**

Abstract. This article analyzes sidewalk accessibility in Lviv, Ukraine, particularly for people with disabilities. The study classifies and identifies problems related to pedestrian infrastructure that hinder mobility for this social group. Various subgroups of people with disabilities are considered, each with specific needs that impact pedestrian movement and can lead to conflicting interests. The case study of Lviv sheds light on the challenges related to accessibility in the city. The vector of the «City of Short Distances» concept development was considered together with the requirements for a pedestrian zone. Through the identified indicators, the study conducted a comparative analysis of the sidewalk's accessibility between distant stops. The findings of this research contribute to the development of social practice theories and enrich the understanding of barrier-free accessibility in urban environments.

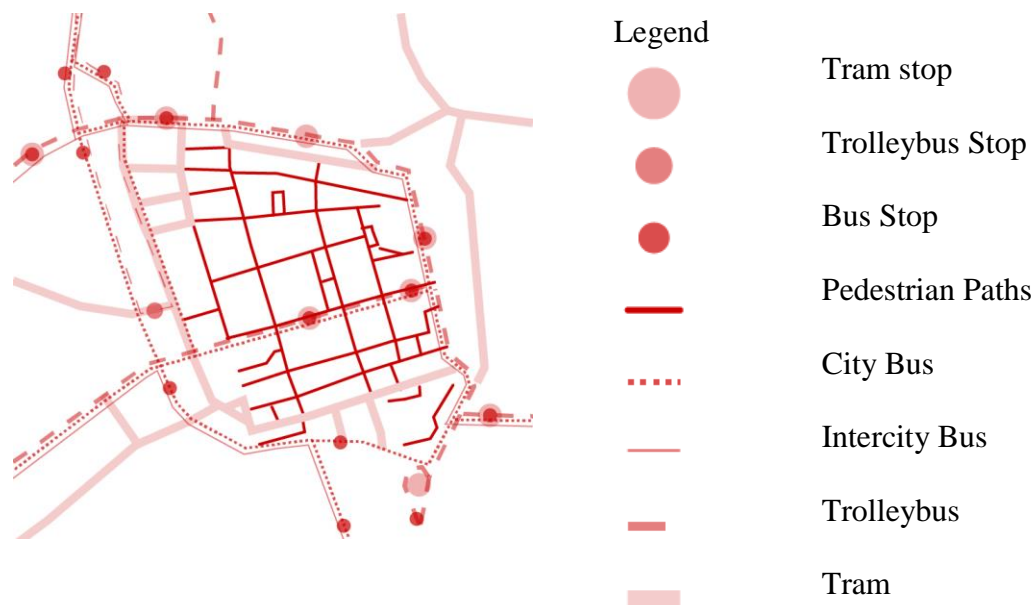
Pic. 1. Diversity of the Street's and Sidewalk's Function in the City Center, 2023, Bakun A., Lytvynenko M.
